NORTH DOOR

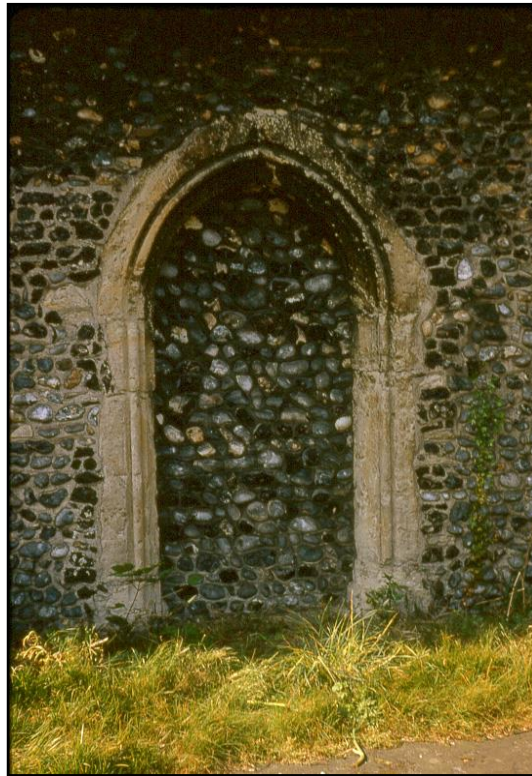
13.

The North door of All Saints Church was in constant use until 1863, when Charles Nightingale Beazley decided to block it up during his 'restoration' of the church. The door had not been blocked up before, so quite why it was decided to do this is a mystery.

The doorway is of Norman design and would have possibly stood in the original old north wall of the little church, before the north half-aisle was added in c. 1360. The flint covering of the opening was part of Beazley's work, which he used on all the external walls of the church except the south wall, which was only partially faced with flints.

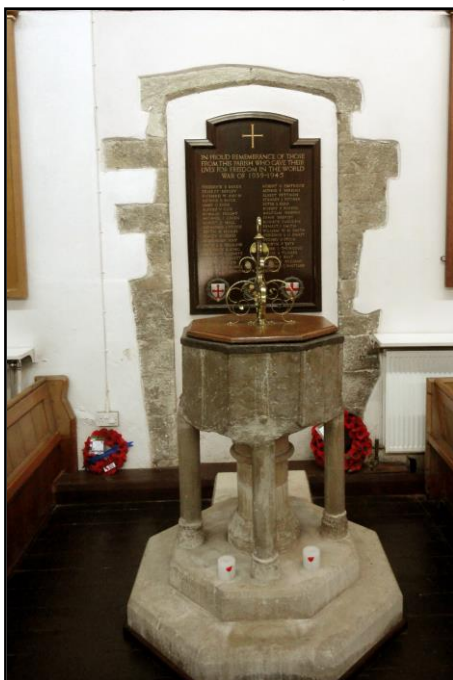
The photo on the left shows the inside view of the doorway, with a clear indication of its shape and size still visible.
